DETERMINATION OF BEARING CAPACITY AND CALCULATION OF THE GAIN OF THE DAMAGED SPAN OF A RAILWAY OVERPASS BY THE FINITE ELEMENT METHOD

The subject of the study the possibility of applying the finite element method to determine the bearing capacity of a damaged reinforced concrete structure and the subsequent selection of its reinforcement parameters with composite materials.

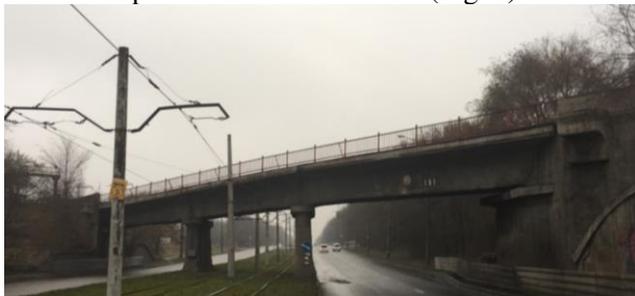
The strengthening calculation was made for the railway bridge overpass Zaporizhia Ferroalloy Plant. The three-span beam overpass has a longitudinal scheme $-16.5 +13.5 +16.5$ m. The angle of intersection of the overpass with the street - 39° (Fig. 1).

Fig. 1. General view of the overpass

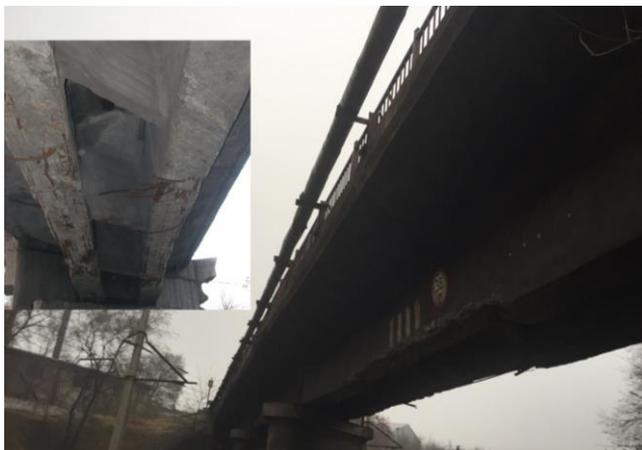
The examination found that one of the spans, located on the side of the ferroalloy plant, has defects in the form of destruction of concrete in the stretched zone and destruction of part of the rods of the working reinforcement. In one rib, the torn two lower rows of reinforcement. The concrete strength of monolithic beams and diaphragms was determined using an ADA Schmidt Hammer 225 sclerometer and is in the range of 25.8-26.8 MPa, which is higher than the design grade of concrete - M250, except for damaged places where the average concrete strength was 18.8 MPa.

Damage (Fig. 3) occurred as a result of the transverse impacts of freight road transport on the lower edge of the beams due to a decrease in the size of the roadway. The reason for the decrease in size is an increase in the height of the carriageway during the repair of road works.

Fig. 3. Damaged span beams

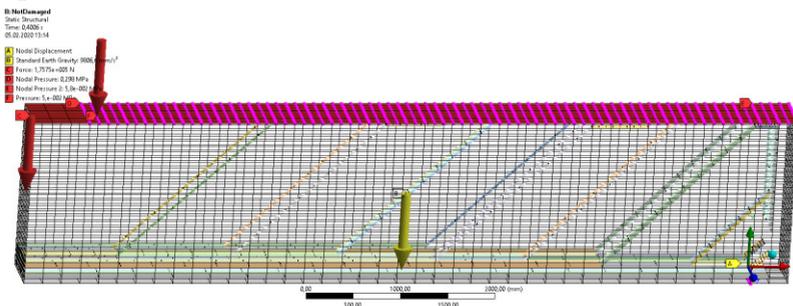
To checking the load-bearing capacity of the beam, 3D models were created in the ANSYS software package that takes into account the geometry of the structure before (Fig. 4) and after its damage (Fig. 5). The load C14 applied to the model following DBN B.1.2-15: 2009 [5] and DBN B.2.3-14: 2006 [6].

In the computational finite element model for numerical analysis, the symmetry of the computational domain taken into account. When creating the calculated finite element (FEM) model, the elements were used: for concrete (B35) - SOLID186, for reinforcement (A-300 steel) - REINF264. When generating a mesh of the reinforcement, the MESH200 element used.

Fig. 4. FEM beam model before damage

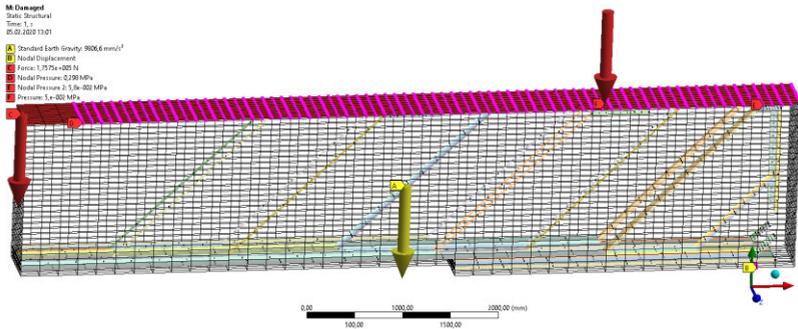
Fig. 5. FEM beam model after damage

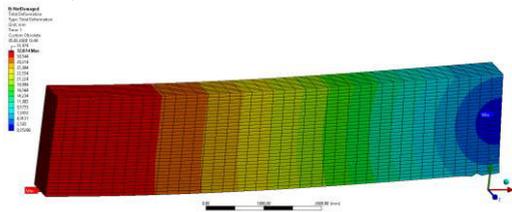
Fig. 6. Estimated beam deformation before damage

Maximum parameter value	Before damage	After damage	Δ , %
Beam deflection	32.87	59.29	59.1
Normal stress in concrete			
tension	3.2	3.3	0.3
compression	24.3	32.37	33.2
The normal stresses in the reinforcement	202.00	447.93	217.5

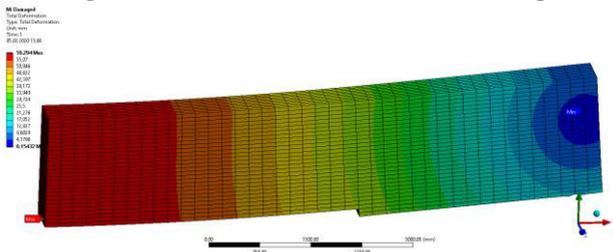
Fig. 7. Estimated deformation of a damaged beam

Although stresses in reinforcement after damage increased by almost two times, the static load-bearing capacity of the beam remains sufficient. However, the deflection of the damaged beam does exceed the permissible values.

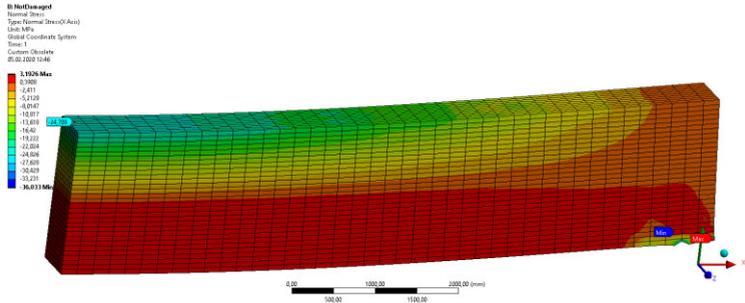
Fig. 8. Normal Stress distribution in the concrete of the beam before damage

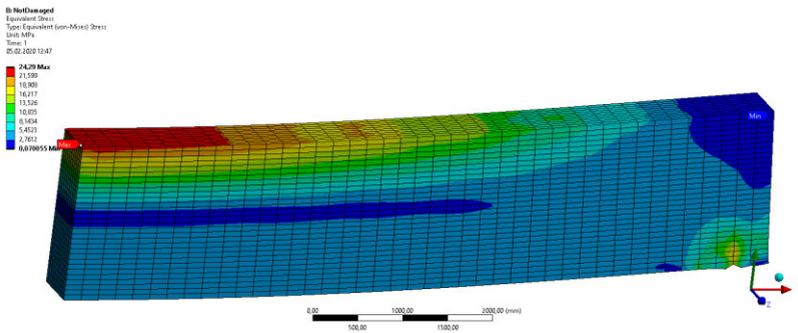
Fig. 9. Equivalent Stress distribution in the concrete of the beam before damage

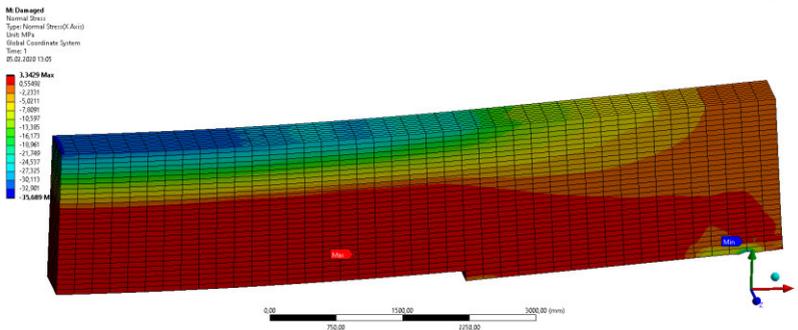
Fig. 10. Normal Stress distribution in the concrete of a beam after damage

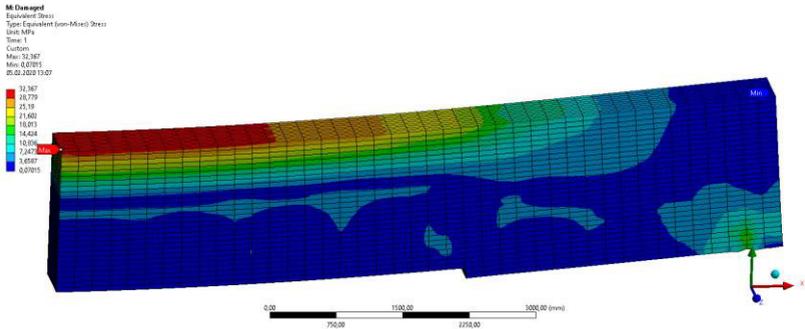
Fig. 11. Equivalent Stress distribution in the concrete of a beam after damage

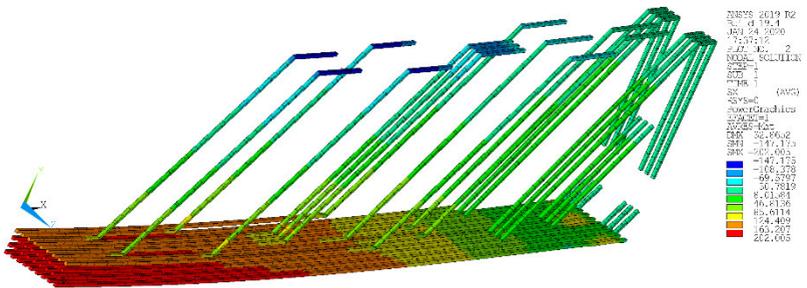
Fig. 12. Distribution of Normal Stresses in the beam reinforcement before damage

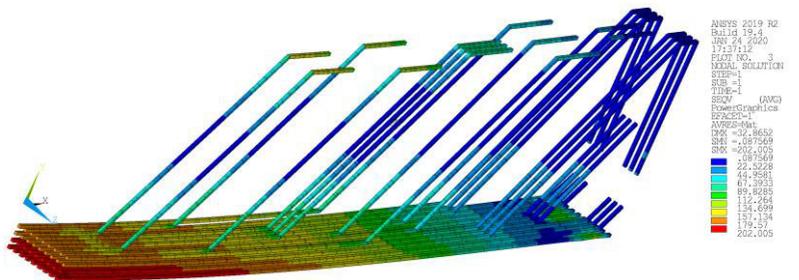
Fig. 13. Distribution of Equivalent Stresses in the beam reinforcement before damage

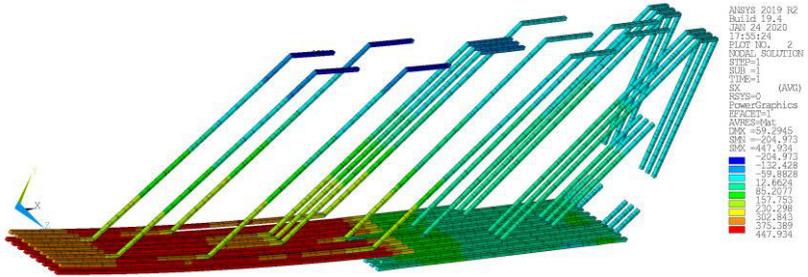
Fig. 14. Distribution of Normal Stresses in the beam reinforcement after damage

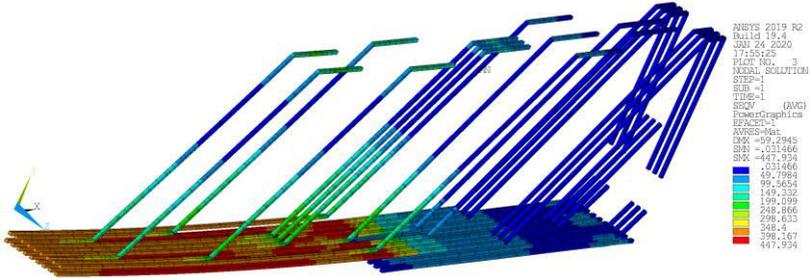
Fig. 15. Distribution of Equivalent Stresses in the beam reinforcement after damage

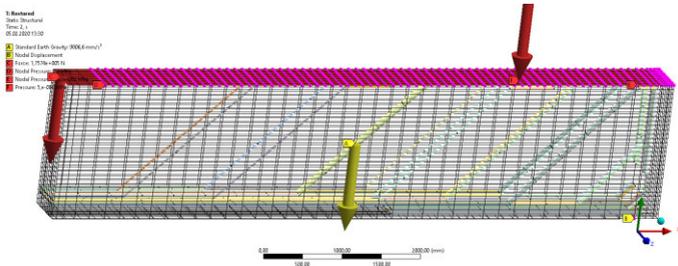
The FEM model of the reinforced beam shown in Figure 17. The distribution of deformations and stresses in concrete and reinforcement shown in Figures 18-22.

Fig. 17. Intensified beam design model

To preventing further destruction of the beam to ensuring its bearing capacity and to preventing's corrosion of the reinforcement, additional reinforcement was developed by gluing a unidirectional carbon fiber Carbon fabric-tape-1000-12K-420.Ct-11083 onto the lower belt of the beam. The concrete coating restored in the zone of damage to the lower belt before gluing the CFRP. The structural characteristics of carbon fiber given in table 1 and figure 16.

The adhesive bonding of concrete and carbon fiber is modeled by Cohesive Zone Material (CZM) using Separation-Distance based Debonding. Contact algorithm: Penalty method. Contact detection at the Gauss integration point. The system generated elements SURF154 and SURF156 to implement the model.

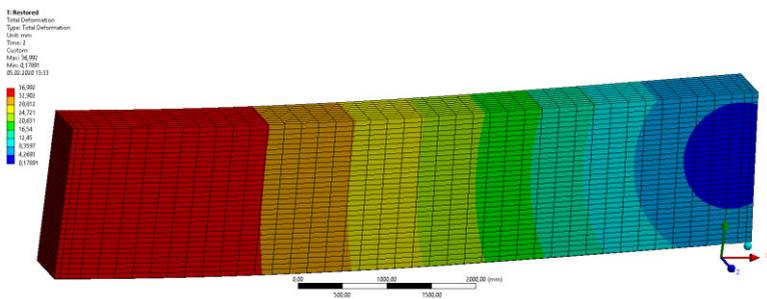
Fig. 18. Deflection of the intensified beam

Maximum parameter value	Before damage	After intensified	Δ , %
beam deflection	32.87	38.5	17,1
normal stress in concrete			
tension	3.2	3.7	15.6
compression	24.3	26.3	8.2
the normal stresses in the reinforcement	202	345	70

An analysis of the results shows that reinforcing the structure with unidirectional carbon fiber with a thickness of 1 mm reduces the increase in deflection from 59 to 17 %, stresses in the stretched zone from 33 to 8 %, and in the reinforcement from 217 to 70 % compared with the unreinforced structure.

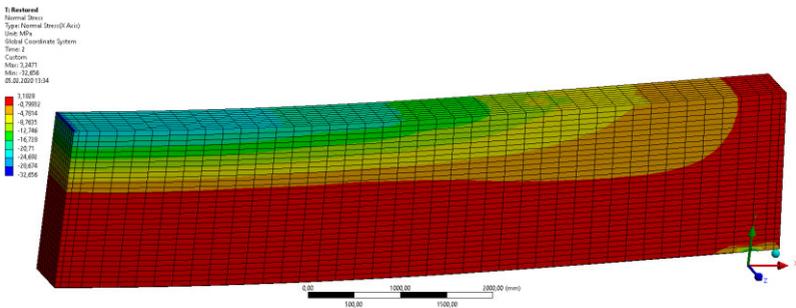
Fig. 19. Normal Stresses in the concrete of intensified beam

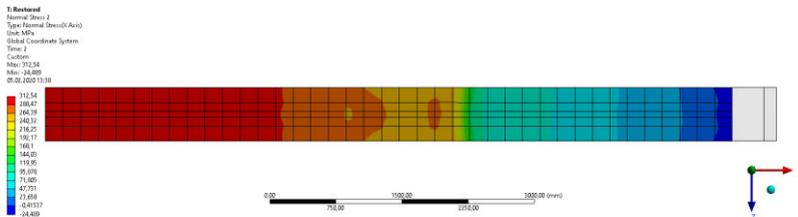
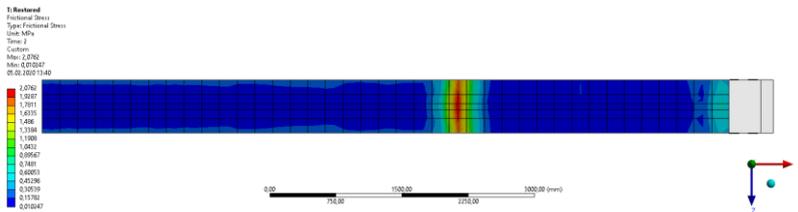
Analysis of the reinforced structure in the ANSYS software package revealed a picture of the normal stress distribution in the gain element, frictional stress between the gain element and the beam, and distribution of pressure in contact zone (Fig. 23-25).

Analysis of the obtained data shows that the maximum stresses in carbon fiber do not exceed 20% of its bearing capacity. The maximum frictional stress between the beam and the carbon element is 3.25 MPa, and maximum pressure in glue is 0.008 MPa, which does not require bonding with high-quality epoxy adhesives.

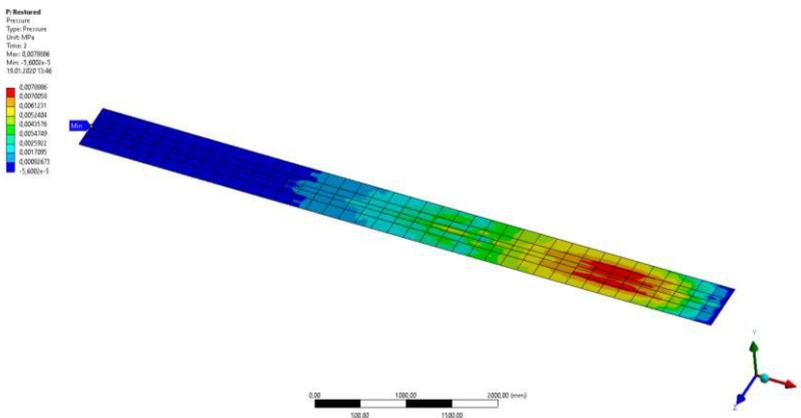
Fig. 25. Pressure in contact between concrete and carbon gain element
